MTP-P&VE-M-62-6

March 5, 1962

**GEORGE C. MARSHALL**

AGING OF INSTALLED RUBBER AND PLASTIC  
GASKETS IN SIMULATED FLIGHT HARDWARE

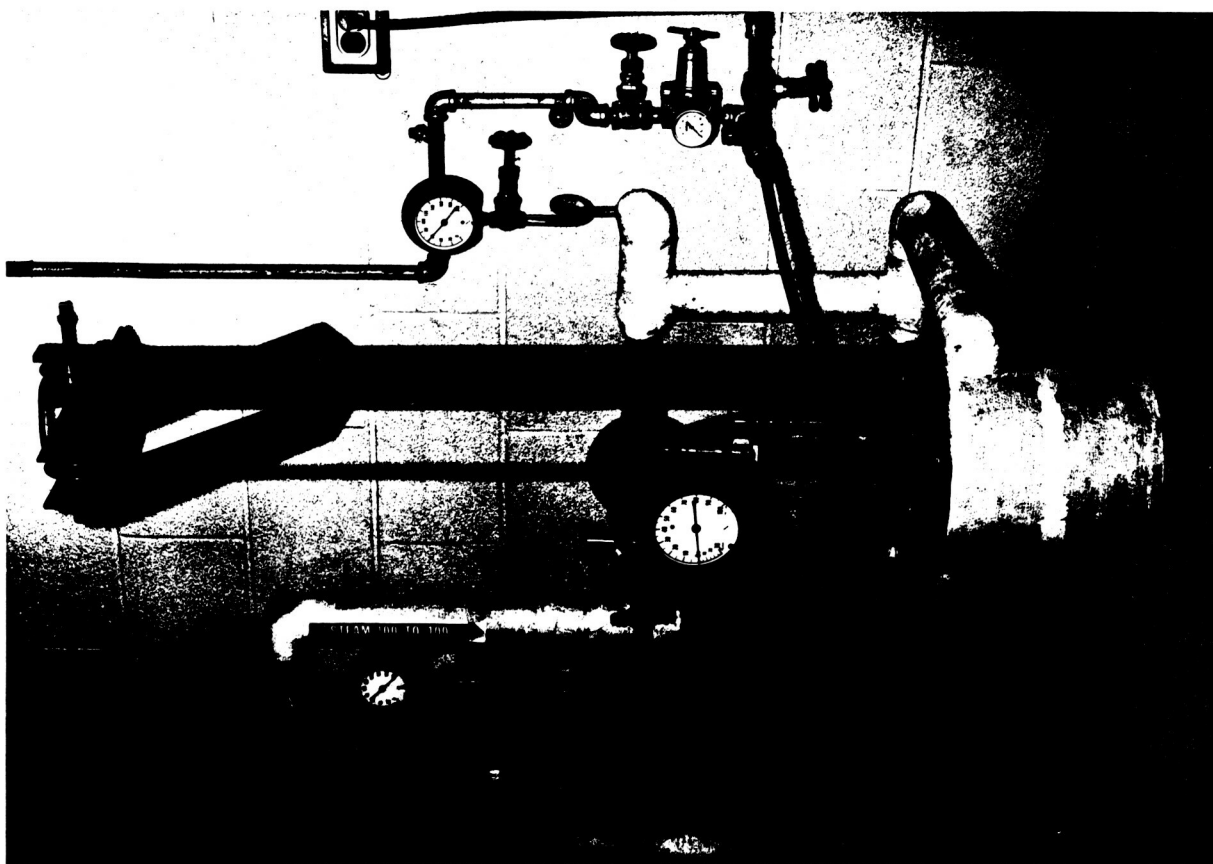
FIGURE 7a AIR BOMB APPARATUS

Rubber samples in the air bomb test are exposed both to oxygen and to heat. The tensile strengths of butyl, one of the nitriles, SBR, natural, and Thiokol rubbers were seriously affected by this test (see Appendix A, Table 7). The loss in tensile strength, except for Thiokol, was probably caused by chain scission resulting from the decomposition of hydroperoxide groups, associated with a double bond, at the elevated temperature of the test. Chain scission in the Thiokol rubber is probably caused from oxygen attacking the polysulfide linkage. Oxygen causes crosslinking of the polymer chains as well as chain scission. The decrease in elongation of the nitrile and Neoprene rubbers, and to a lesser extent the SBR rubbers, was caused by crosslinking of the polymers. The properties of the other seven (excluding Thiokol) saturated elastomers were not appreciably affected by this test. However, as the temperature is increased, the reaction kinetics favor an increased probability of chain scission at the weaker linkages, and at higher temperatures, the properties of the seven saturated elastomers would be seriously affected.

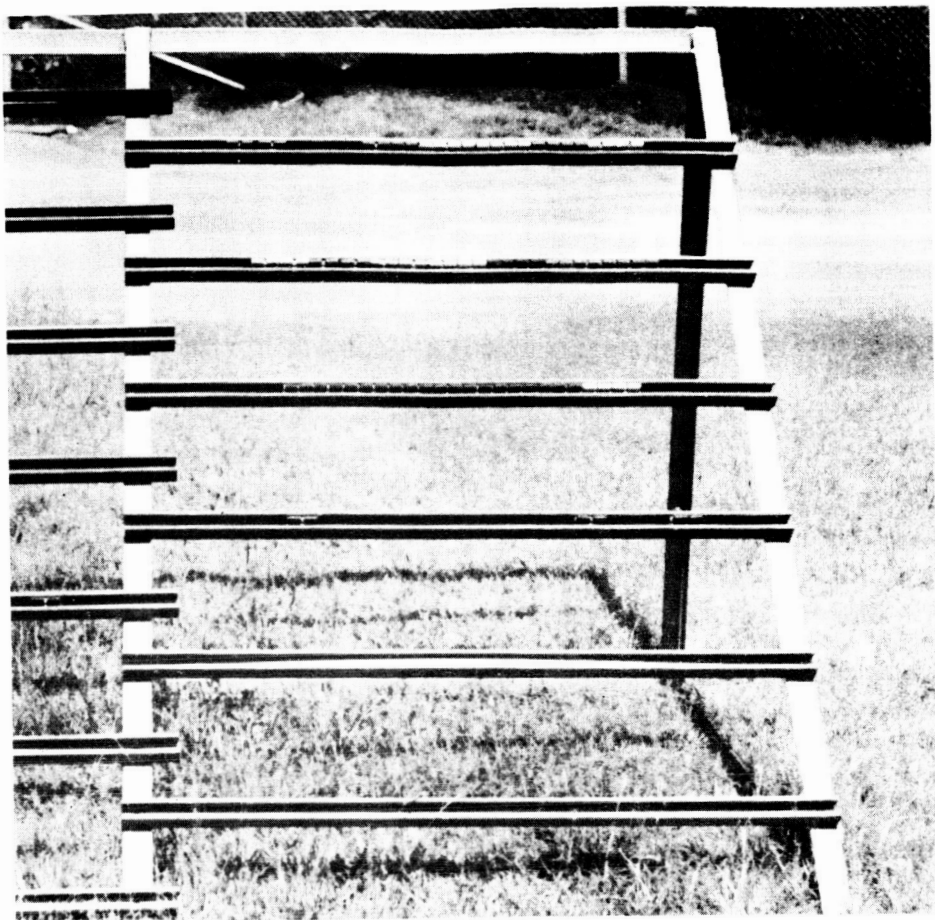
FIGURE 8a OUTDOOR AGING RACK

The effects of normal weathering at MSFC on rubber samples were determined according to ASTM Procedure D 518-57T, Part B. In this test, duplicate looped specimens, having varying degrees of elongation along the length of the loop, were exposed to weather and sunlight at an angle of 45 degrees facing south (see Appendix D, FIG. 8). The samples were examined periodically (daily initially, and later, weekly) for the appearance of surface cracks by which failure is indicated. The results of the outdoor weathering tests are presented in Appendix A, Table 9. The effects of outdoor weathering and resulting surface cracks on natural rubber samples are shown in Appendix D, FIG. 9.

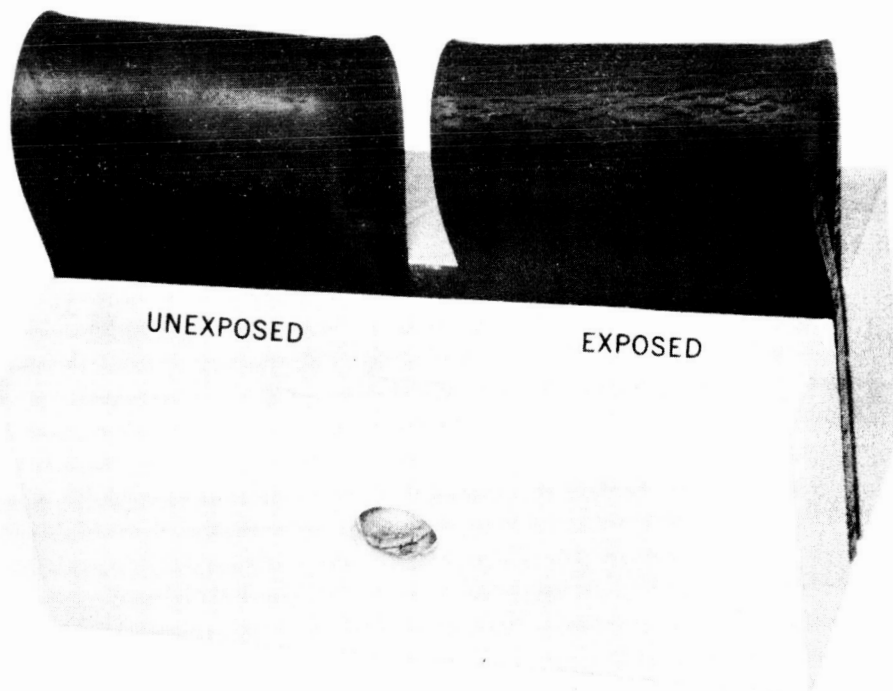
FIGURE 8b OUTDOOR AGING SPECIMENS

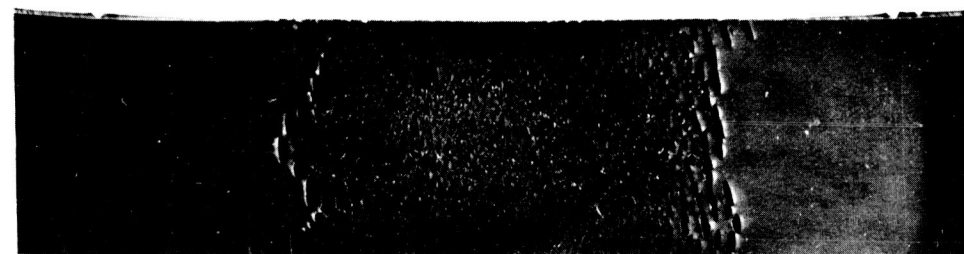
FIGURE 9 OUTDOOR AGING OF NATURAL RUBBER SHOWING THE DEVELOPMENT OF OZONE CRACK IN BENT LOOP SPECIMENS

Specimens of natural rubber exposed to outdoor weathering produced cracks in seven hours, in three days for SBR rubber, and in eight days for Nitrile rubber. Butyl rubber lasted seven months, and Neoprene failed in fifteen months. Although the data are incomplete, the results show that fluorosilicone, silicone, and Viton-A rubbers are much less adversely affected by weather and sunlight than is Neoprene.

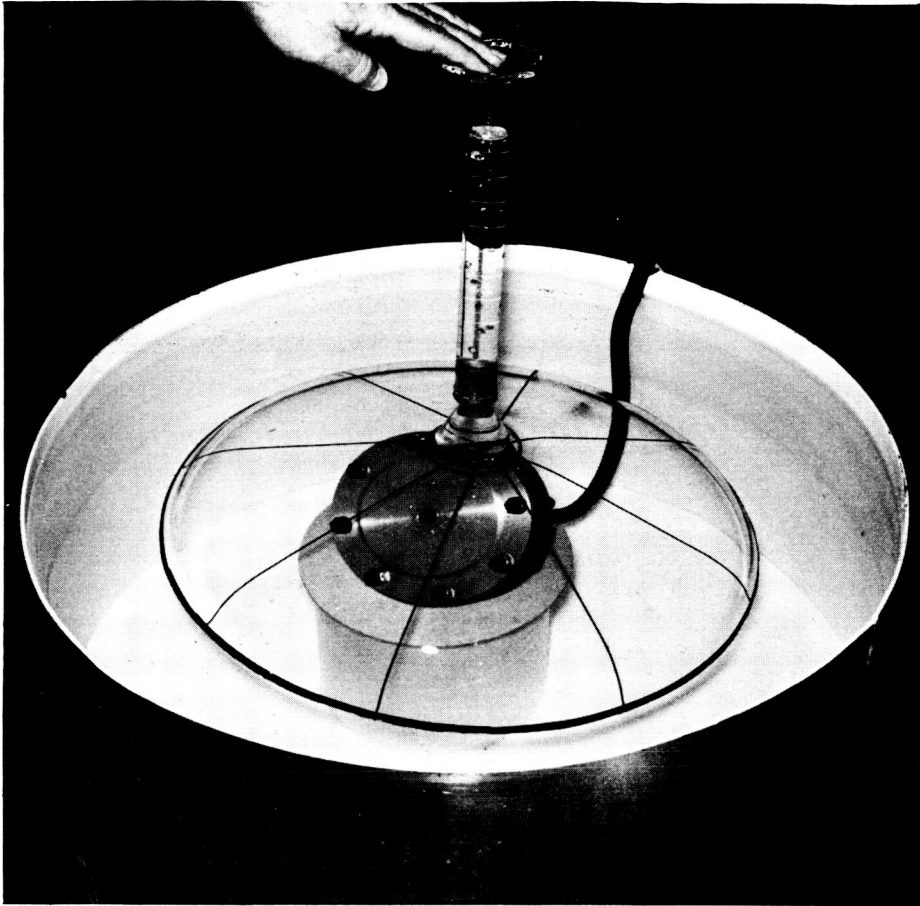
FIGURE 10a LEAK RATE MEASUREMENT

The leak test consisted of applying gas pressure to the test fixture, according to procedures outlined in Appendix C. Each assembly was equipped with an AN-815-4 fitting to facilitate pressurization of the fixture (see drawing, Appendix B). Compressed nitrogen gas was used to pressurize the test fixture by means of the pressure control panel shown in Appendix D, FIG. 10. Each installed gasket was pressure tested at the test pressures listed in Appendix A, Tables 10 thru 17. Leakage rates were measured by collecting the escaping gas in a graduated cylinder by water displacement for a specific time interval as illustrated in Appendix D, FIG. 10. Allowable leakage rates for all static seals (except thrust chamber seals) are defined as follows:

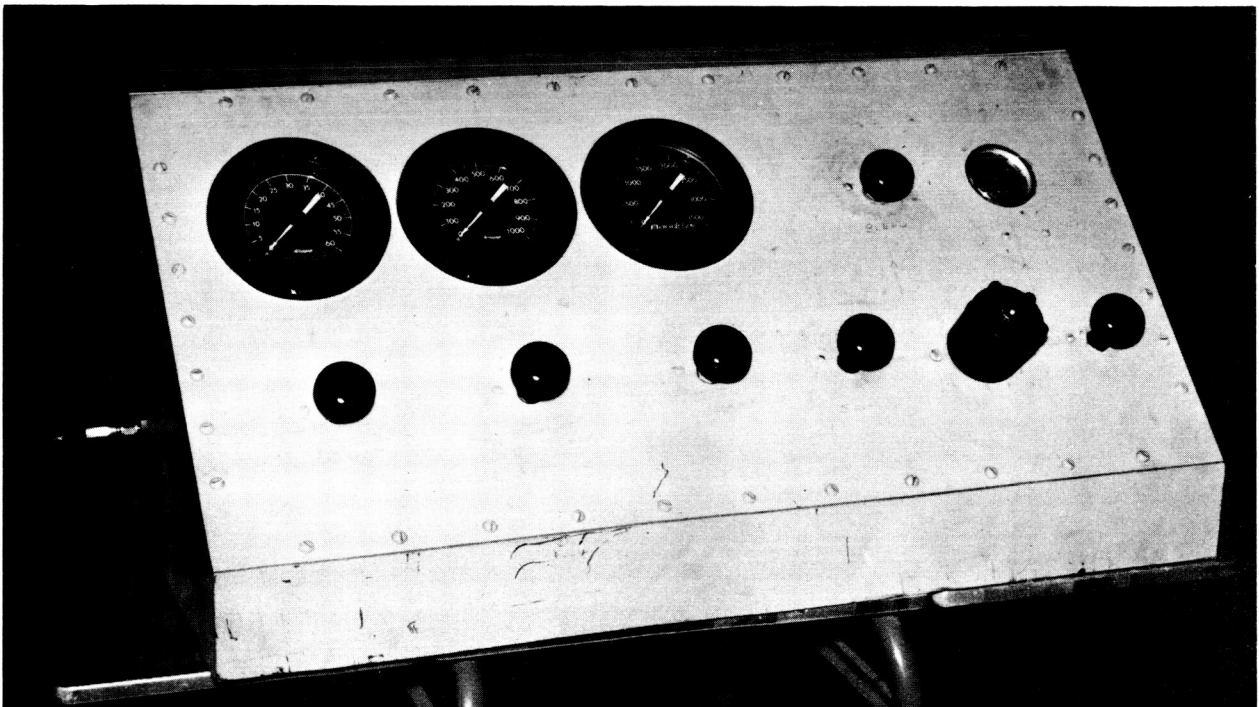
FIGURE 10b LEAK MEASUREMENT CONTROL PANEL
